Boatbuilding on a grand scale

Testing large bonded-in fasteners

By Brian Knight

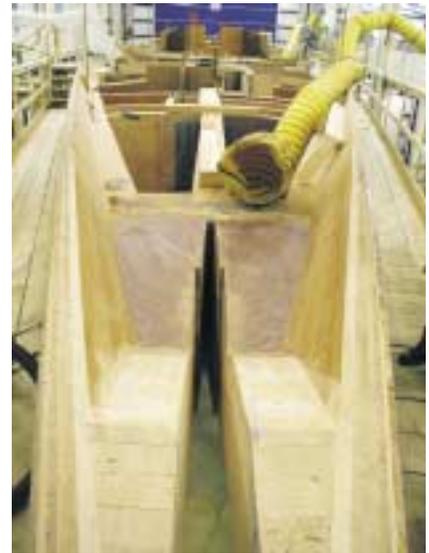
Scheherazade's propeller shaft strut before it was attached to the hull. The strut was built of carbon fiber by Goetz Marine Technologies.

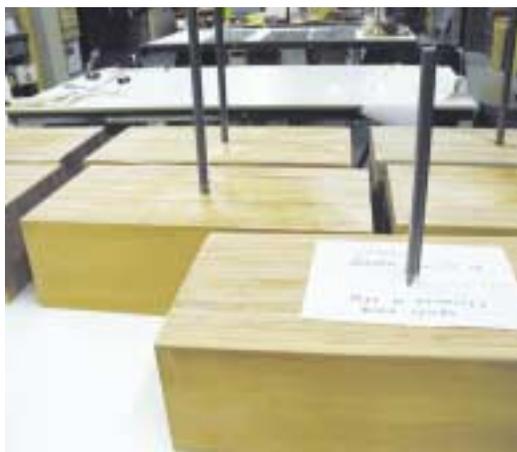
The 3/4" diameter stainless steel bolt test samples before the test. In these samples, the rods were imbedded parallel to the glue joints.

(Although the boat's hardware will be fastened with bolts, for the tests we used threaded rods of the same diameter and material.)

For the tests on the 3/4" stainless steel rods, we built seven laminated wood blocks, 12" x 24" x 5 1/2" thick. All were laminated 3/4" clear Douglas fir. The photo (*top*) shows how the bolt was oriented relative to the grain of the wood. We drilled one " diameter hole into each of these samples and bonded a rod in the center of each hole. Two of the rods were imbedded 5" deep and five rods were imbedded 6" deep.

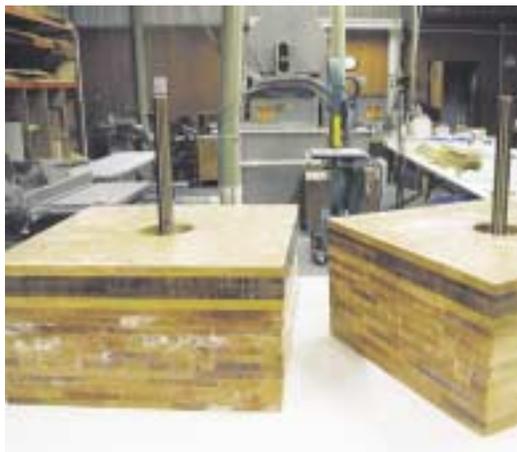
The 1 1/2" diameter silicon bronze bolt test samples before the test. In these samples, the rods were imbedded perpendicular to the glue joints. The top six laminations represent Scheherazade's outer skin over a heavy laminated frame.

quired to extract these fasteners was expected to be very large (50,000 lb+), so we increased the size of the panel to 24"×24"×12" thick. The wood grain is oriented differently in this test than in the 3/4" rod test (*middle photo, previous page*). This reflects the way the grain is oriented in the hull of the boat. Each fastener was bonded into a 1" hole drilled 9" deep.

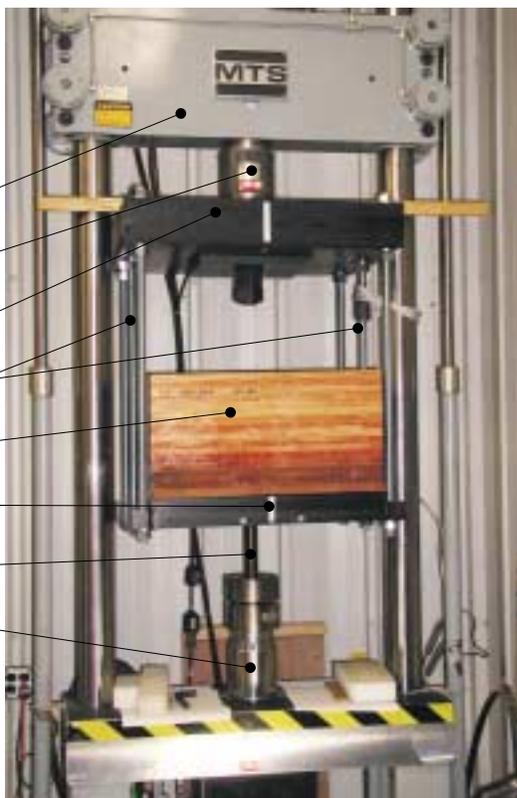
The MTS test machine with the test apparatus and 1 1/2" silicon bronze bolt test sample before the test.

- Test frame crosshead
- Load cell
- Monolith
- 1" steel rods
- Test block
- Frame
- 1 1/2" bronze rod
- Test machine actuator

The end of the bonded-in fastener is threaded into a socket on the actuating cylinder on the base of the test machine. The test is performed by pulling the bonded threaded rod downward out of the wood block. We knew that we needed a very substantial method of holding the wood sample up while the fastener is withdrawn from it.

The wood block is held in a 1" steel angle frame. The frame is suspended by six 1" threaded steel rods attached to a wood/steel composite slab just below the top of the test frame. The slab is a 4 1/2" thick plywood core sandwiched between two pieces of 1/4" steel, bonded together with epoxy, and nicknamed "the Monolith" (from the movie *2001: A Space Odyssey*). The Monolith is anchored to the crosshead of the MTS Test Frame with a 2" diameter bolt. At the very top of the test apparatus is the cylindrical load cell, which measures the force the machine is exerting on the fastener.

It is not an easy thing to hold onto a piece of wood and pull on the other side of it to the tune of more than 50,000 lb, but that is exactly what we hoped our apparatus would do. Between the frame, the six steel threaded rods, the Monolith, the 2" diameter bolt, the 1 1/2" silicon bronze threaded rod, and a test machine with a pulling capacity of 100,000 lb, something has to go. We hoped it would be the epoxy joint or the wood, not the fixture or the test machine.

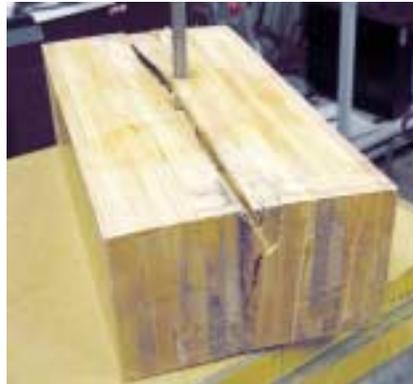
In the smaller, 3/4" rod tests (*left and middle*), with the rod imbedded parallel to the glue joints, the damage looked quite different than it did in the larger 1 1/2" rod test (*bottom*), with the rod imbedded perpendicular to the glue joints. The quality of the wood in the samples also varied between the two tests.

In both tests, the machine's travel limit was set to 1", so the rod remained partially imbedded in the block.

It took an average of 22,000 lb of force to remove the 3/4"×6" embed, 19,400 lb to remove the 3/4"×5" embed and 55,000 lb of force to remove the 1 1/2"×9" embed silicon bronze rods. The force required in pounds per square inch of hole surface area ranged from 1,000 to 1,600 psi depending on the quality of the wood in the test sample.

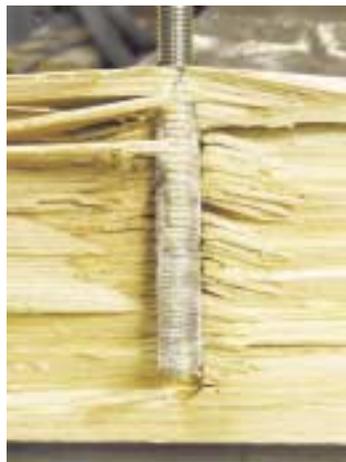
A tested 12"×24"×5 1/2" sample was split apart after a test. This sample had a large crack running the complete length of the sample after the test had finished (*above*). I drove a wedge into the crack which split the block the remaining distance. The photo (*left*) shows how the wood adjacent to the threaded rod was destroyed—graphic evidence of the forces exerted during this test.

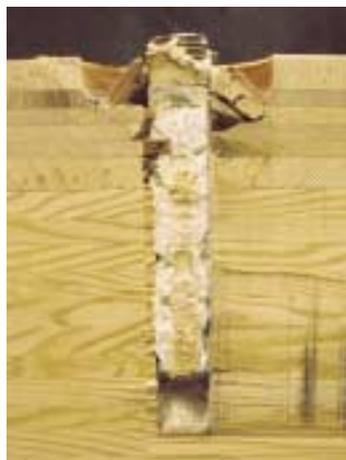
A tested 24"×24"×12" sample was cut apart on a large band saw so we could examine what happened in the area around the bolt. The photo (*left*) shows that the wood was permanently deflected around the bolt. You can see the distortion in the glue line where the wood was bent in the direction of the bolt movement. The wood fiber closest to the bolt is distorted more than the fiber farther from the bolt. This is the result of the wood compressing near the bolt and crushing. Farther away from the bolt, the distortion becomes less noticeable until, a few inches from the bolt, there is no visible deflection. ■
